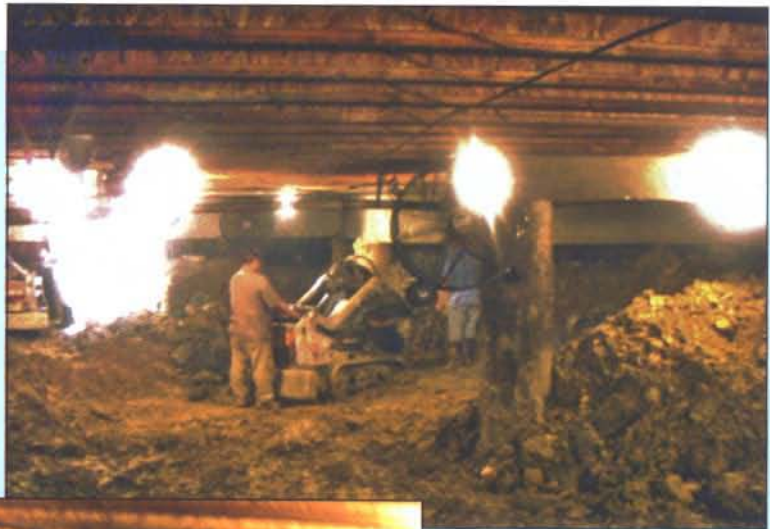
*Excavating under the building.*

The pier replacement area was accessed by excavating under the building with small rigs, relocating utilities where required and keeping the building operational at all times. The piers were 18" diameter, 35' deep from the paving surface and penetrated 10' into gray shale with an average SPT of 100/1.

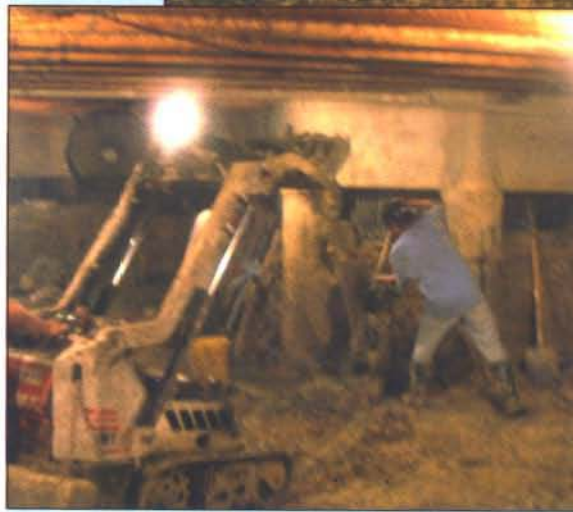
*Drilling under concrete beams.*

*As shown in the photo that follows, these piers were drilled under grade beams with as little as 5' clearance. All piers were, however, 18" diameter and over 30' deep including the 10' of shale penetration.*

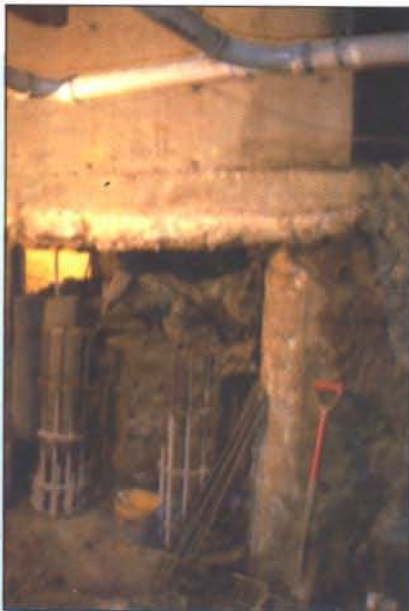
*Steel extended up from piers.*

Reinforcing steel diameter was kept to  $\frac{3}{4}$ " in order to reduce the lap, which in these tight quarters would have greatly increased steel cost. The laps were necessary in order to set the steel in short sections. This result-

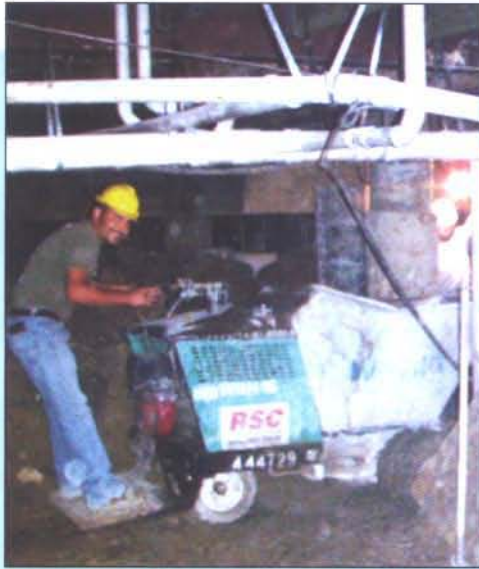
Concrete placement.

Concrete was amassed at the outside of the building using motorized buggies and transported to each pier for placement. This required sequencing of all movement under the building since there were several operations

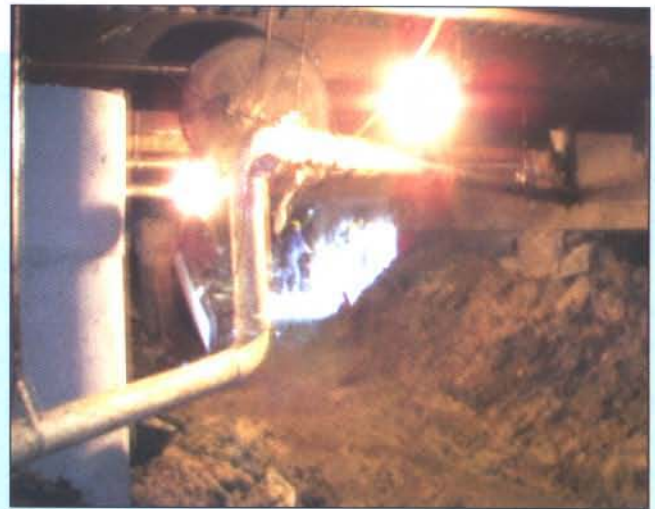
The following photo shows the very tight quarters and the Bobcat MT. It is so small that the operator must walk behind the machine. Four of these rigs were utilized on the job for performing the exca-

Main access route.

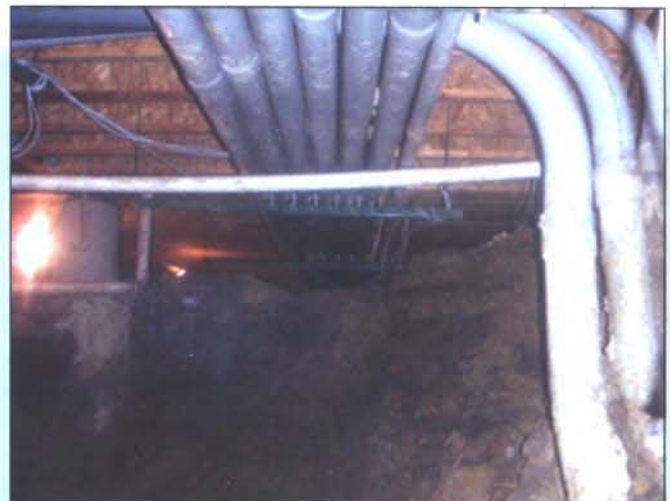
As would be expected, power, sewer, water and communication utilities were in large supply under the building. This

*This required excavation and drilling operations to be carefully executed not only due to safety concerns, but because any break in these lines might shut down the entire hotel.*

Concentration of utilities.

There was also one area where the concentration of utilities was so great that we could not install piers without the complete rerouting of these lines. This would have shut down hotel operations. When presented with the circumstances, and with management's on-site inspection of actual conditions, the decision to omit these areas became an economic determination that was embraced by all.

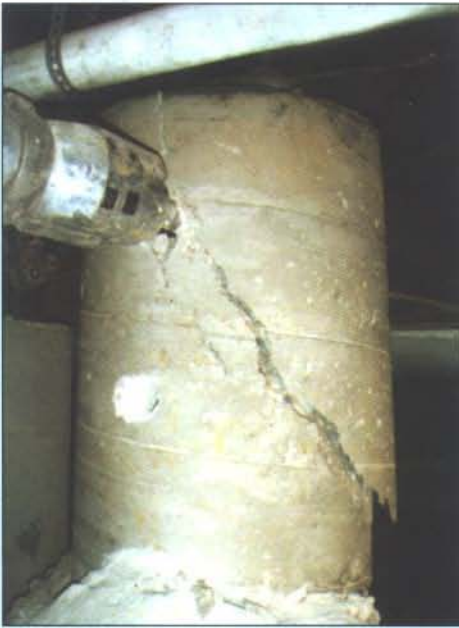
*Spreader bar breaking existing pier.*

pilot hole into the pier, setting a spreader bar and expanding to rupture the concrete. This saved a considerable amount of time. The photo above shows how the spreader broke the pier.

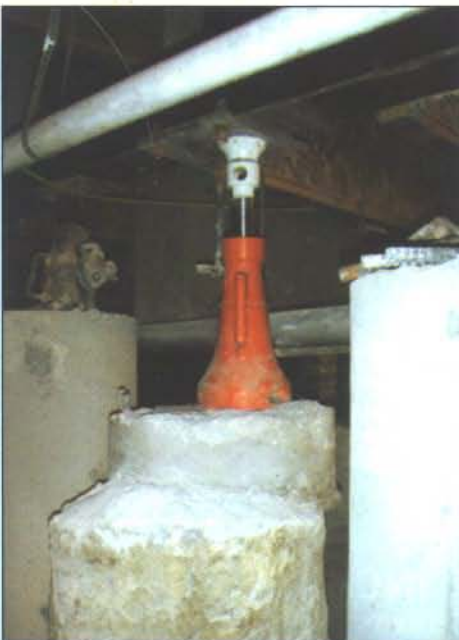
When a section of piers was completed, it was necessary to install jacks between beams and pier tops, cut away the existing piers that were being replaced by the remedial piers, and smooth the top so that a screw jack could be installed between the existing pier and beam (wood, concrete and steel beams). Using the remedial piers, the building in each section was adjusted vertically to meet the topography goal. The screw jack was then adjusted on the existing piers so that jacks on the remedial piers could be removed and the formed section could then be poured between new piers and building beams.

*Screw jack set in place.*

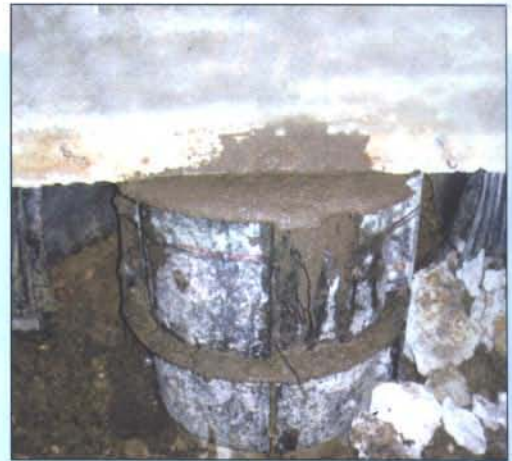
Connection from the new piers to existing beams consisted of drilling into the beams, installing dowels secured with epoxy in the drilled holes at the concrete beam interface. The section from new pier to existing beam was then formed and poured with Siki-Quick 1000, which had

a 15 minute set time. At the juncture of the wood and steel beams, it was necessary to install "J" bolts to attach to the beam and secure them laterally and vertically.

*Pier cap poured under beam.*

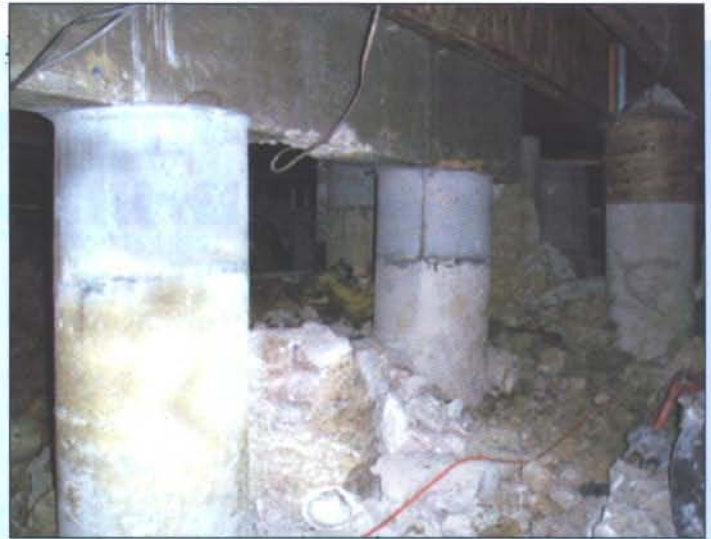
*Finished pier columns up under foundation.*
